## **Spring 2011 Levee Inspection Results**

## **Reclamation District No. 1601 Twitchell**

## Levee Inspection Report By Mile - Spring 2011

Waterway		Unit Miles	Inspection Start/End	Inspector
Unit No. 01 Threemile Slough	Left	2.47	03/29/2011 03/29/2011	Richard Willoughby

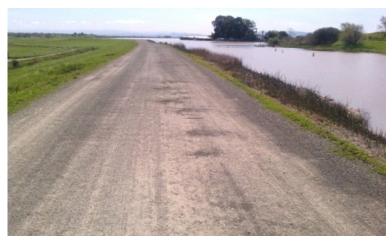
richard\_s\_20110330\_476.jpg

Levee Mile Report Line	3
Start Levee Mile	0.10
End Levee Mile	1.31
Location	Crown
Category	Earthen Levee
Item	Crown Surface / Depressions / Rutting
Looking south at crown s	urface rutting.
